Simulated Solar Flare X-Ray and Thermal Cycling Durability Evaluation of Hubble Space Telescope Thermal Control Candidate Replacement Materials

Prepared for the
Fourth International Space Conference on Protection of Materials and
Structures from the LEO Space Environment
sponsored by the University of Toronto and the Institute for Aerospace Studies
Toronto, Canada, April 23–24, 1998

During the Hubble Space Telescope (HST) second servicing mission (SM2), astronauts noticed that the multi-layer insulation (MLI) covering the telescope was damaged. Large pieces of the outer layer of MLI (aluminized Teflon[®] fluorinated ethylene propylene (Al-FEP)) were cracked in several locations around the telescope. A piece of curled up Al-FEP was retrieved by the astronauts and was found to be severely embrittled, as witnessed by ground testing. The National Aeronautics and Space Administration (NASA) Goddard Space Flight Center (GSFC) organized a HST MLI Failure Review Board (FRB) to determine the damage mechanism of the Al-FEP in the HST environment, and to recommend a replacement thermal control outer layer material to be installed on HST during the subsequent servicing missions. Candidate th

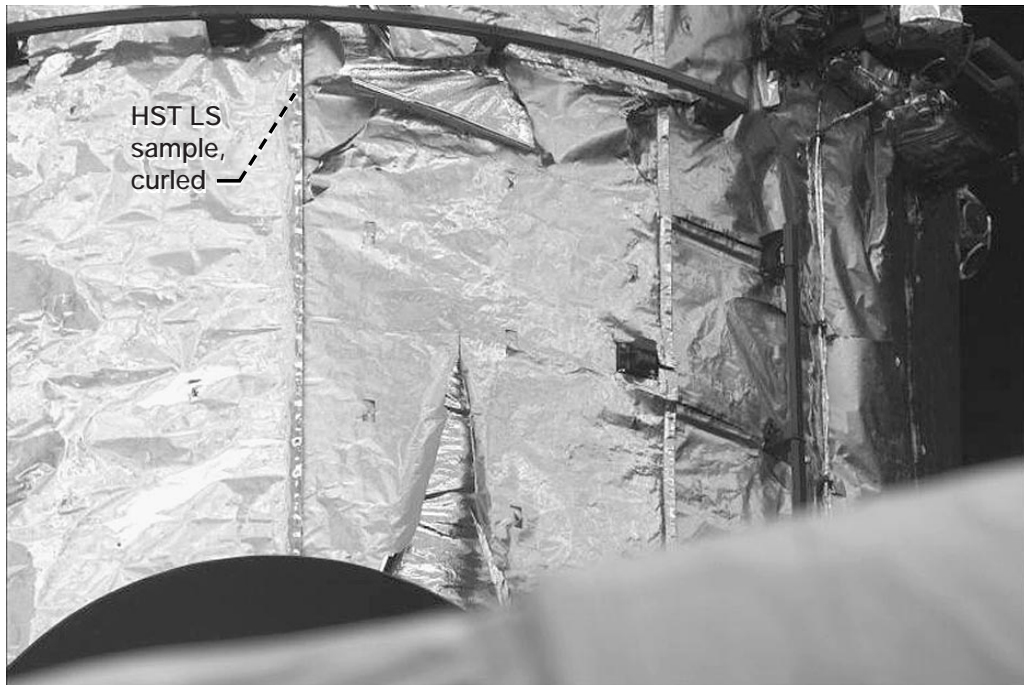
Figure 1. Extensive tearing/curling damage to MLI exterior layer on HST as photographed during SM2. The tightly curled-up piece was cut off by an astronaut and retrieved for analysis (SM2 LS sample) prior to patching the area.

During SM2, severe cracking of the MLI outer layer material was observed on the Light Shield (LS), Forward Shell (FS) and Equipment Bays of the telescope. Astronaut observations combined with photographic documentation of HST taken during SM2 has revealed extensive cracking of the MLI in many locations around the telescope, with solar facing surfaces being particularly damaged.¹ The MLI outer layer at several of the longest cracks was observed to be curled up and lifted away from the next MLI layer. Figure 1 shows severely degraded MLI on HST as photographed during SM2.

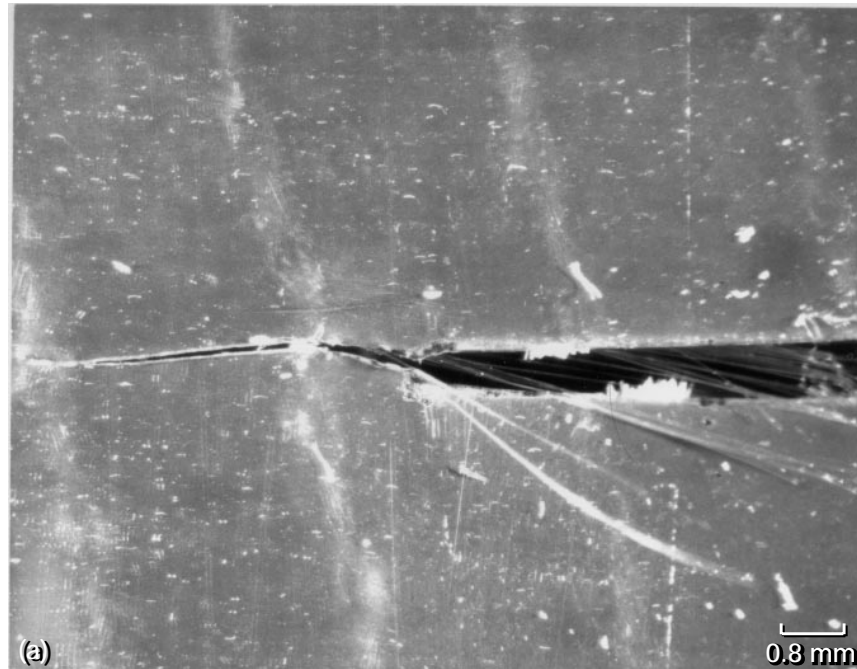
Figure 10. Candidate sample B1.6 after thermal cycling. (a) Close up of purposely cut region showing fine tear which propagated during thermal cycling. (b) Backside of sample showing the tear extending to the second fiber bundle beyond the cut.

Optical microscopy was used to document the extent of damage which occurred at the purposely cut area with thermal cycling under load. The initial cut lengths and tear lengths propagated during thermal cycling are listed in Table 5. The fiberglass/Kapton[®] samples (B1.2 and B1.4) tore in half. The tear lengths for the Nomex[®] scrim samples ranged from 1.8 mm (0.071") to 5.3 mm (0.209"). The Ag/Inconel Nomex[®] samples (B1.1 and B1.5) had shorter tears than the Al Nomex[®] samples (B1.3 and B1.6) of the same FEP thickness. The Nomex[®] scrim on the Al samples was not as orthogonal as the Ag/Inconel samples (as can be seen by comparing B1.1 and B1.6 in Figure 5) which may have contributed to the small additional tearing. Sample B1.7 had a very fine hairline crack which was 5.3 mm long, and the witness Al-FEP sample (B1.8) had a tear length of 42.6 mm. Figure 10 shows tearing of the cut tip in sample B1.6. The backside of the sample shown in Figure 10b shows the tear extending to the second fiber bundle, with no damage to the uncut fiber bundles near the propagated tear.
